# Home Report

304 Dykehead Road,  
Riggend,  
AIRDRIE,  
ML6 7SR

# Single Survey

<b>Property Address</b>	304 Dykehead Road, Riggend, AIRDRIE, ML6 7SR
<b>Reference</b>	1585520
<b>Customer Name</b>	Dawn Wilkie
<b>Date of Inspection</b>	18th May 2026
<b>Surveyor's name, qualifications and office</b>	Kenneth Geddes BSc (Hons) MRICS DM Hall LLP Chartered Surveyors Unit 3, Cadzow Park 82 Muir Street Hamilton ML3 6BJ  Tel: 01698 284939  email: hamiltonresidential@dmhall.co.uk
<b>Prepared By</b>	DM Hall LLP

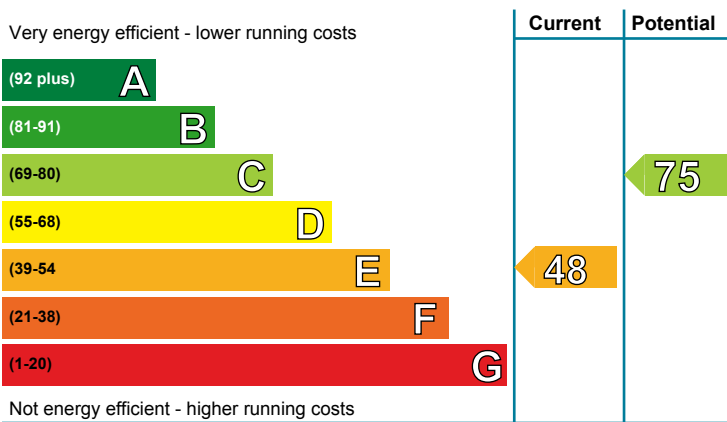
## Energy Efficiency Rating

This graph shows the current efficiency of your home, taking into account both energy efficiency and fuel costs. The higher this rating, the lower your fuel bills are likely to be.

Your current rating is **band E (48)**. The average rating for EPCs in Scotland is **band D (61)**.

The potential rating shows the effect of undertaking all of the improvement measures listed within your recommendations report.

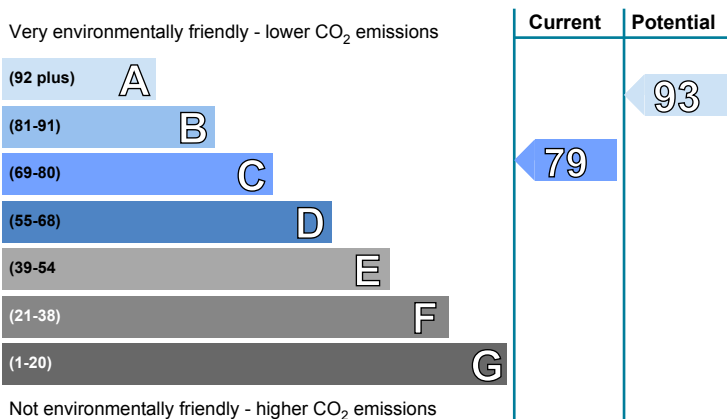
## Environmental Impact (CO<sub>2</sub>) Rating

This graph shows the effect of your home on the environment in terms of carbon dioxide (CO<sub>2</sub>) emissions. The higher the rating, the less impact it has on the environment.
